Investigation of ERCP-Scope X-32

following detected contamination after cleaning and disinfection

--- REPORT OF THE FORENSIC ENGINEERING INVESTIGATION ---

Final version – May 15, 2017

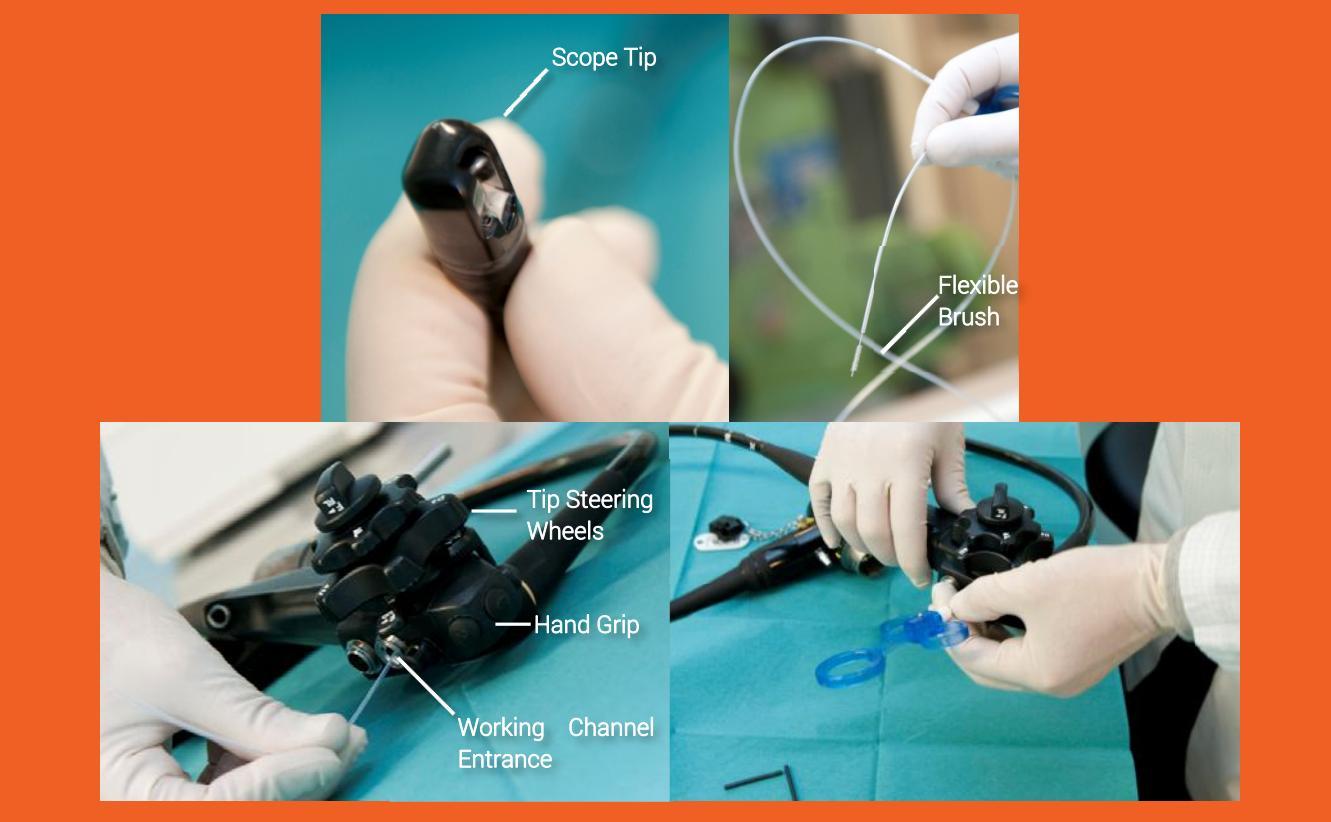
Figure 1: (Top) Tip of Scope X-32 and the flexible brush used for (Bottom) sampling the working channels.

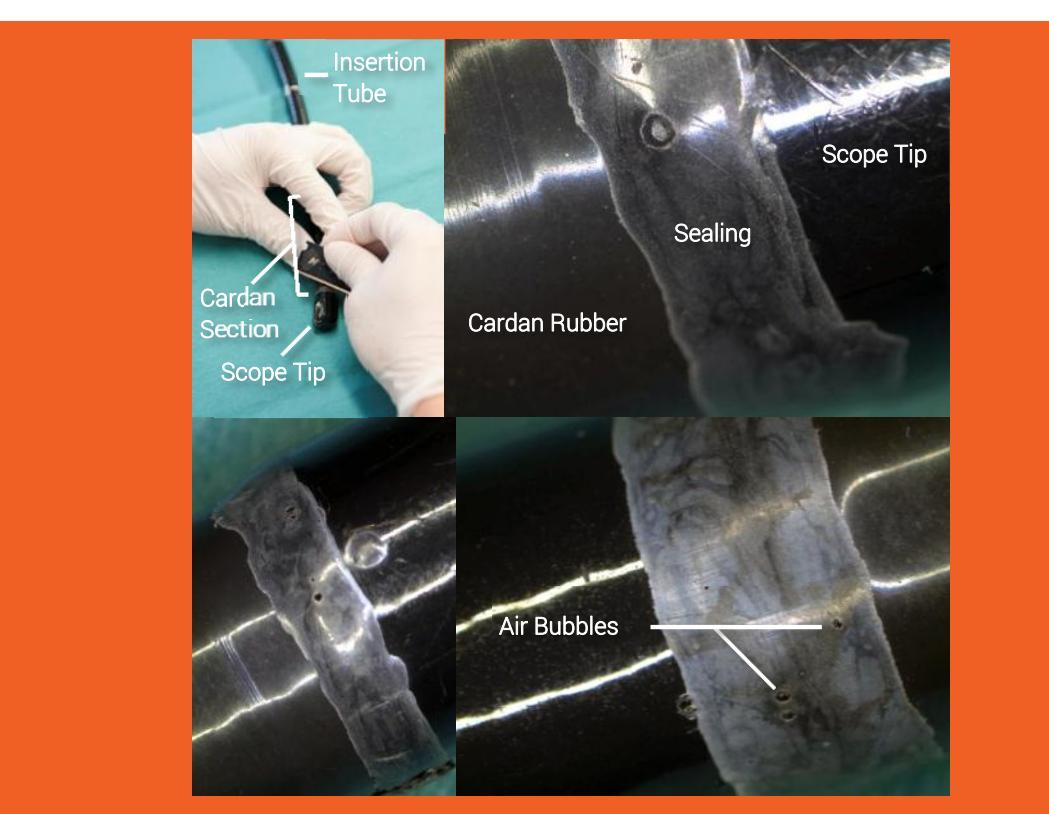
- 11:40h *The investigation team* continues in the manufacturing hall. The rest of the investigation will take place here.
- 11:43h Lin makes the first cut in the sealing of the cardan rubber, directly behind the tip of the scope and then observes air bubbles in the sealing. Arjo requests to pause in order to first take photos of the sealing (Figure 3).

Figure 3: Cutting the seal between the cardan rubber and the tip open. Microscope photos of the air bubbles (some of them are open) in the yet untouched parts of the sealing.

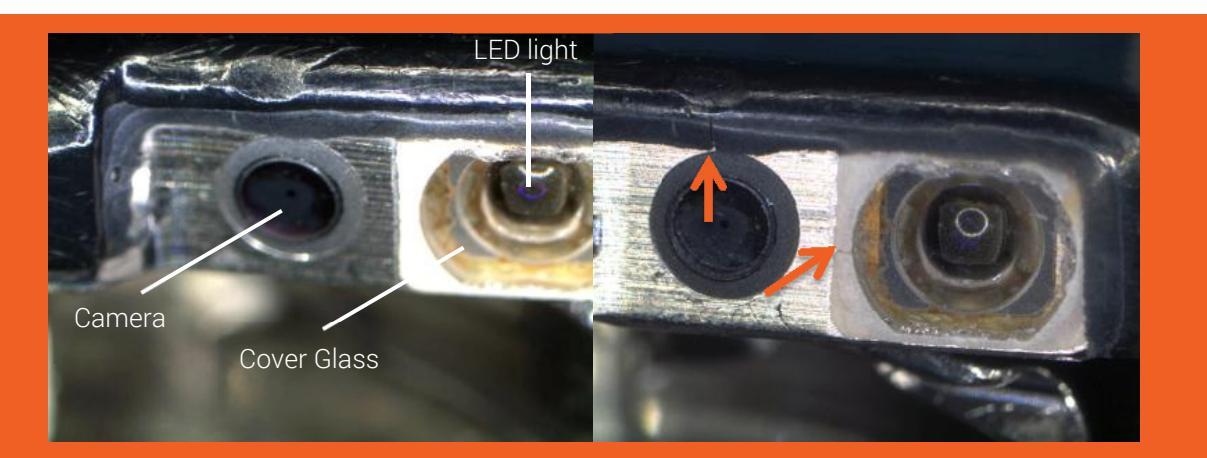
- brownish scale **behind** the cover glass of the LED light (Figure 4)
- cracks in the sealing of the tip housing around the camera and LED light (Figure 4)

Figure 4: Visual inspection of Scope X-32 camera housing. (Left) It is clearly visible that brownish scale is located behind the cover glass. (Right) The vertical arrow points to the tear in de sealing of the tip housing. Another tear in de sealing next to the camera is indicated with the diagonal arrow.

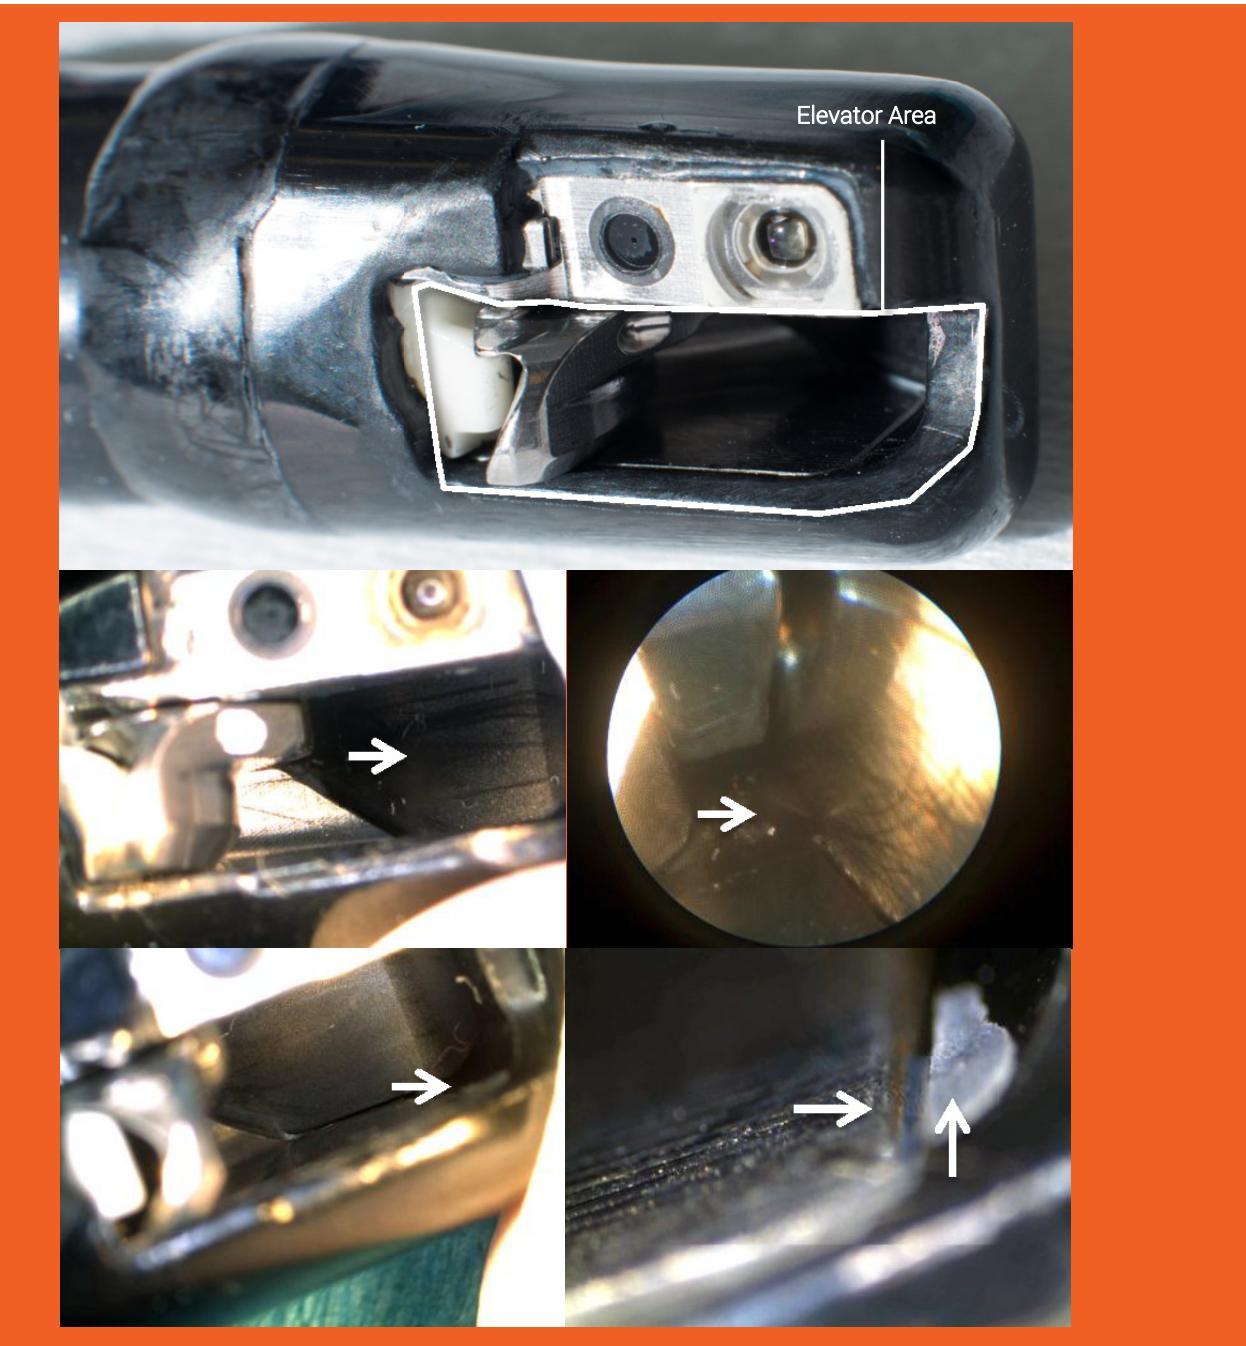
- scratches and grooves on the tip housing surfaces under the forceps elevator,
- whitish scale on the tip housing and brownish scale on the metal surrounding the forceps elevator. Scale is sampled by scraping with a scalpel {5412, 5423, 5434}.

Figure 5: Visual inspection of the elevator area, which is the space around the forceps elevator. (Top row) Overview of the elevator area with the forceps elevator moved all the way up. (Middle row) Scratches and grooves below and behind the forceps elevator; the arrows point to the scratches. (Bottom row) Whitish and brownish scale (arrows) on the surface along which the forceps elevator moves.

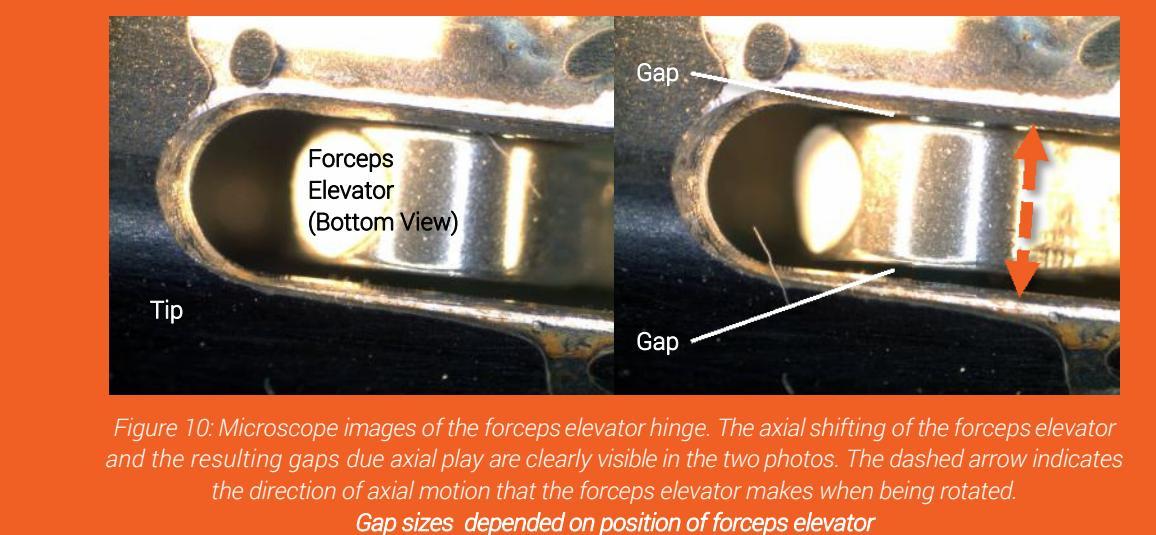
Microscopic inspection of the actuation axle that runs through the forceps elevator to rotate it (Figure 10) revealed that there was a lot of axial play on the axle: It could clearly move back and forth between the two walls that enclose the elevator.

and varied between 0 and 0.2 millimeters.

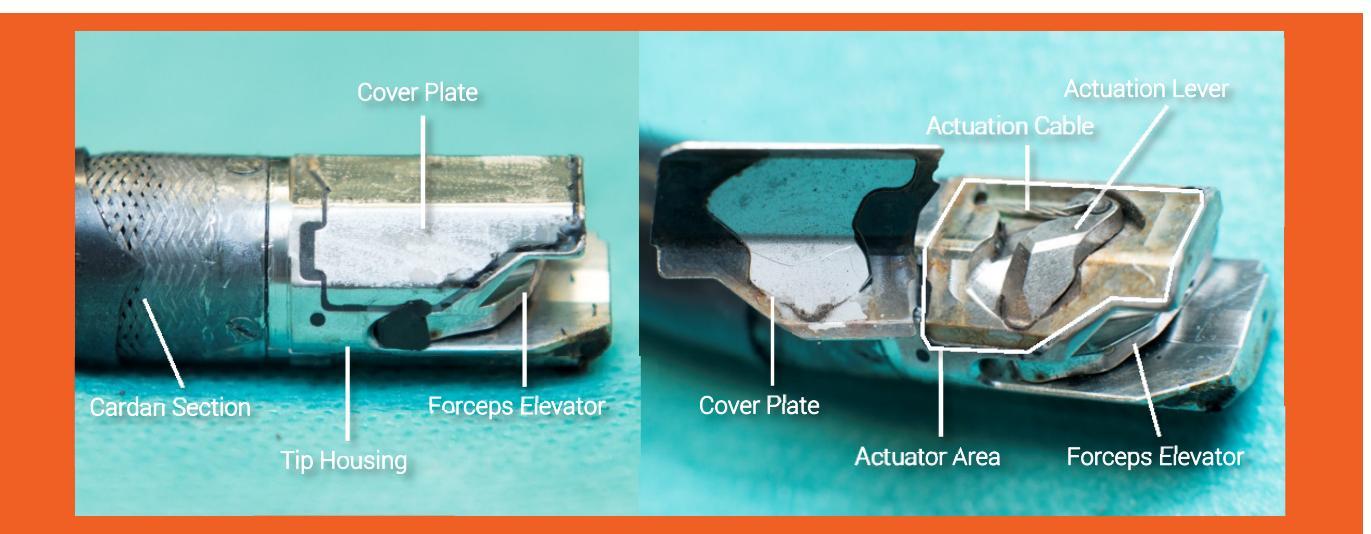
The investigation team clearly notices that all metal surfaces inside the opened actuator area are covered in brown scale. Bacterial testing of the samples will have to show whether this is oxidation, blood or something else.

Figure 11: (Left) Tip with the cover plate still closed. (Right) Tip with the cover plate opened, revealing the actuator area.

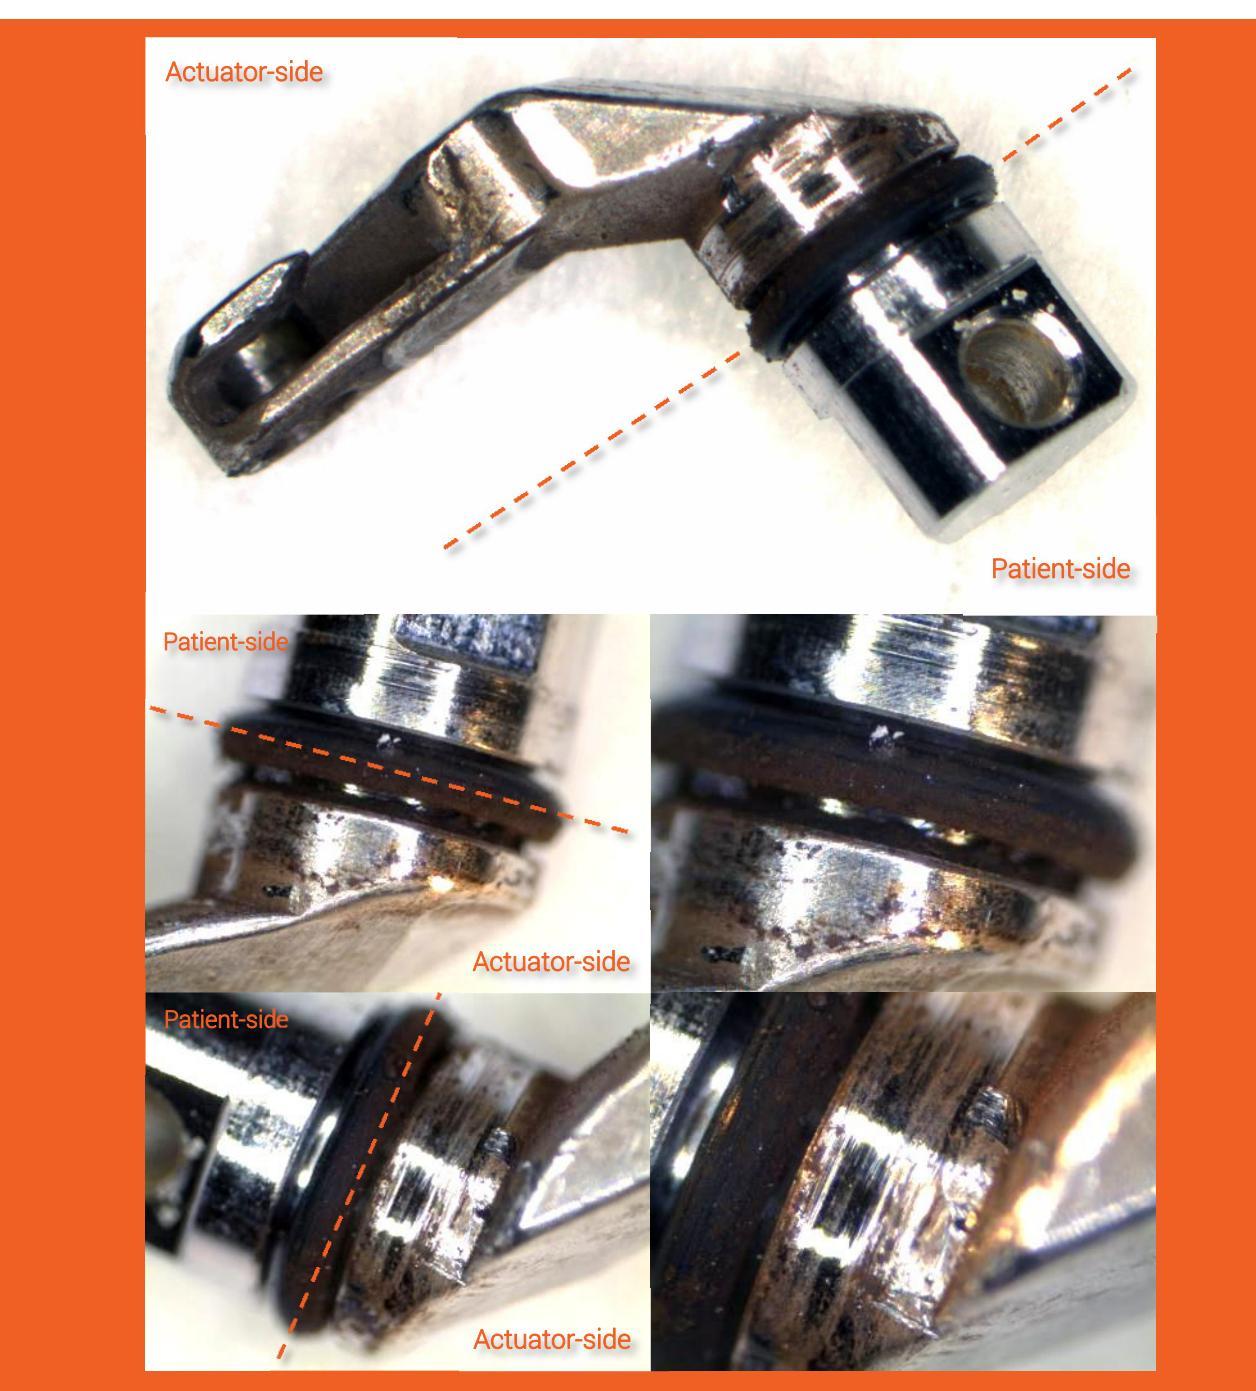
All surfaces of the lever and actuation axle that were located in the actuator area (the actuator-side) were covered with brown scale (Figure 15). The actuation axle looks clean at the side where the forceps elevator (and thus the patient) was located, the patient-side.

The difference between the brown-scaled actuator-side and the clean looking patient-side of the actuation lever with actuation axle is clearly visible (Figure 15). The O-ring shows

signs of wear and is covered with brown scale on the actuator-side. On the patient-side of the O-ring the brown scale is present too, but to a lesser extent.

Figure 15: Microscope images of the actuation lever with actuation axle and O-ring. In the bottom set of four photos the right hand photos are enlargements of the middle sections of the left hand photos.
