9.1 General data on drinking water network in the Netherlands

9.2 Development drinking water network

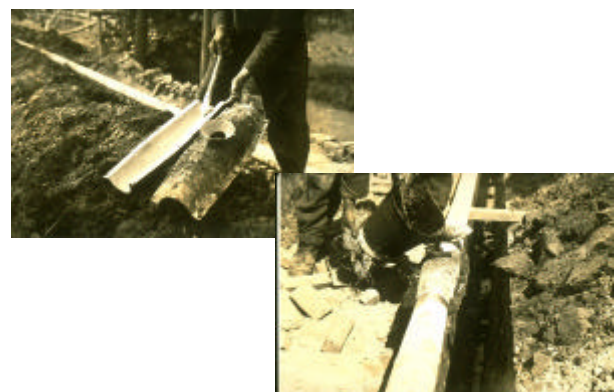
Fig. 2 - Hemp-lead joining of cast iron pipes

As joining technique the lead joints were used in combination with hemp. Figure 2 shows the technique.

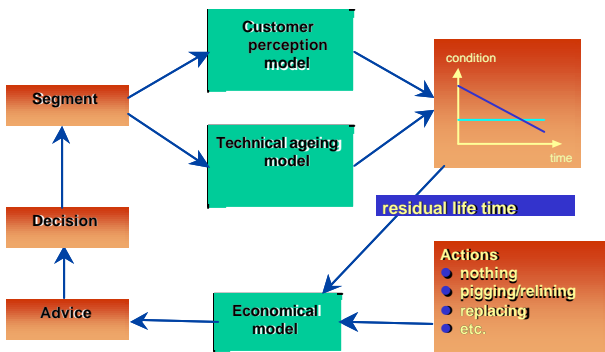
Fig. 4 - Decision support system for piped networks

A simpler version, concentrating more on the degradation aspects of asset management is given in figure 4. This model has the form of a decision support model.

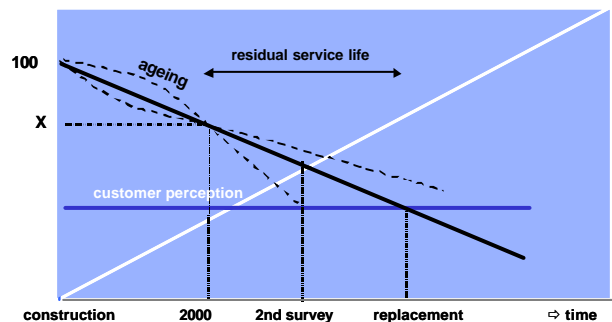
Fig. 5 - Estimated residual lifetime

Basically the material pipes are made off will deteriorate over time. Cast Iron will rust and loose strength, as will AC as result of leaching of material. Based on a assessment of the present condition the deterioration over time can be determined considering that the original condition was 100%. This is visualised in figure 5.

In the figure 5 the assessment of the condition took place in the year 2000 and was found to be X% of the original 100%. How this is determined will be explained later on. Based on a minimum requirement for this pipe, the customer perception, and an assumption on how the deterioration will propagate

over time, the residual lifetime can be determined. In this picture a simple rectilinear relation is assumed, but more complicated relations are also possible. However with a relative lack of knowledge the rectilinear relation gives a good impression of the expected lifetime. It is also an indication on when to do a second survey of the condition to see how the development is and base decisions on it.

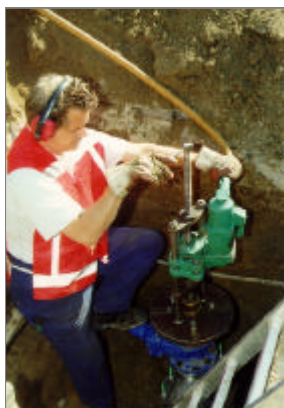
Fig. 6 - Coupon sampling

First analysis concerns the failure rates of the pipe. A failure is a good indication that something is wrong with the pipe and analysis of the failures gives information about the condition of the rest of the pipe. Basic question is what the major cause of the failure was and whether it was material related or environment related. A failure a result of someone damaging the pipe has obviously nothing to do with the material and can be considered as an incident. Taking a coupon out of the pipe and examine this is a proactive assessment of the strength of the pipe. (see figures 6 and 7)

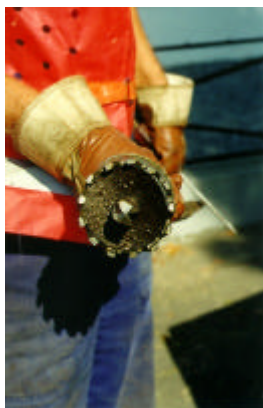
Fig. 7 - Coupon after sandblasting and assessment of residual wall thickness

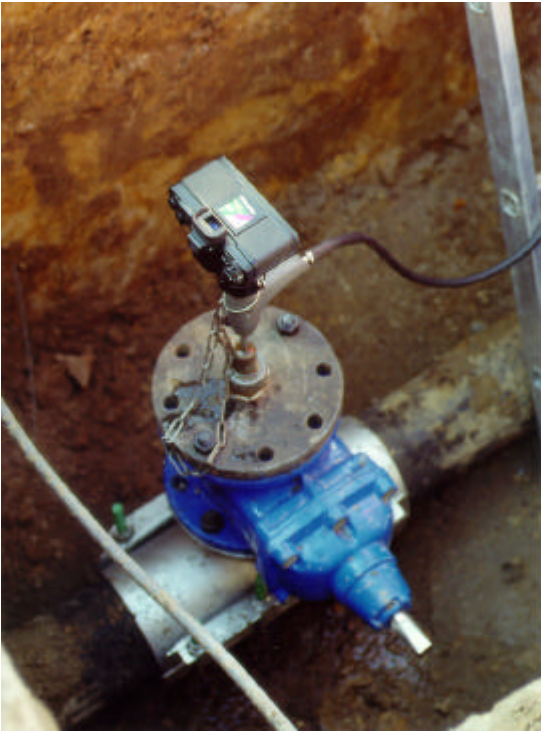
Fig. 9 - Camera for inspection of the pipe

The effect of the deposits can be visually assessed by camera inspection. The camera is inserted in the pipe (figure 9) and pictures can be taken. One must realise that only a limited part of the pipe can actually be seen.

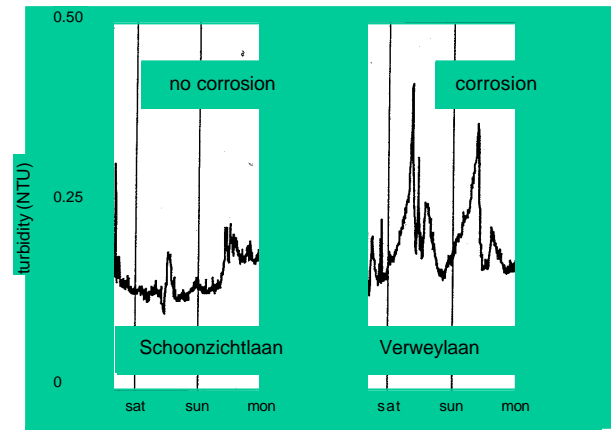
Fig. 11 - Turbidity patterns in a cast iron network

The corrosion of the cast iron can have an effect on the water quality. The water will discolour and become more turbid if the corrosion process actively releases parts to the water. With a continuous monitoring of the turbidity this can be assessed. Figure 11 gives two patterns of turbidity in a cast iron network.

The left graph shows a pattern that is smooth and equals the pattern as it leaves the treatment plant. The second pattern has a daily fluctuation, which has no correlation with the treatment plant pattern. A rise of turbidity during night hours indicates a release of corrosion products causing this increase in turbidity.

The rise is not recognisable during the day hours because residence times then are smaller and the water does not have the opportunity to pick up the particles to a level of increase of turbidity.

This pattern is typical for an active corrosion process. An intense form of this corrosion is often seen after a too rigorous cleaning of the cast iron. The protective layers of corrosion products are damaged giving the material a chance to release corrosion products again.

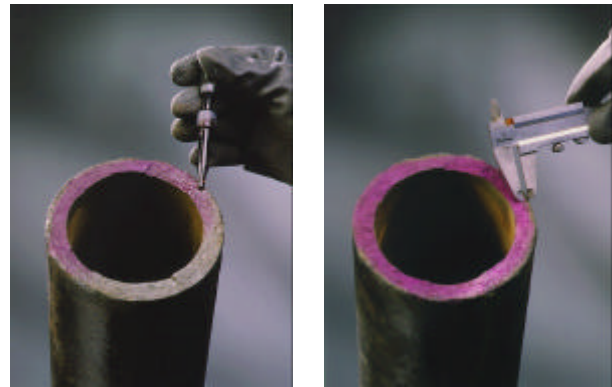
Fig. 12 - Phenolphthalein field test

To assess the amount material lost c.q. the amount of material left the so-called Phenolphthalein field test is developed. In this test a pipe sample is taken and the chemical indicator Phenolphthalein is dripped on the surface. In the places the material has lost its integrity because of the leaching the Phenolphthalein stays colourless, while in the sound areas the Phenolphthalein will colour purple. This is demonstrated in figure 12.

Simply simply measuring the grey areas can assess the degree of deterioration. Of most of the pipes data on the original pipe wall thickness is available.

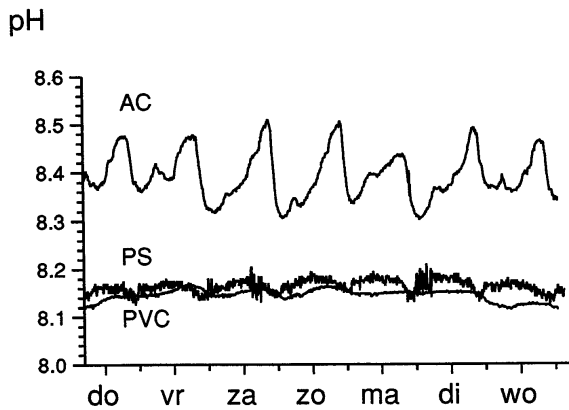
Fig. 14 - Changing of pH as results of passage to AC pipes

Leaching of calcium hydroxide changes the pH of the water. With continuous monitoring of water quality this can be measured in the network. An example of this is shown in figure 14.

In unfavourable circumstances (long residence times and aggressive water) the pH can reach values like 11 or 12. Although extreme and rare these values do appear.

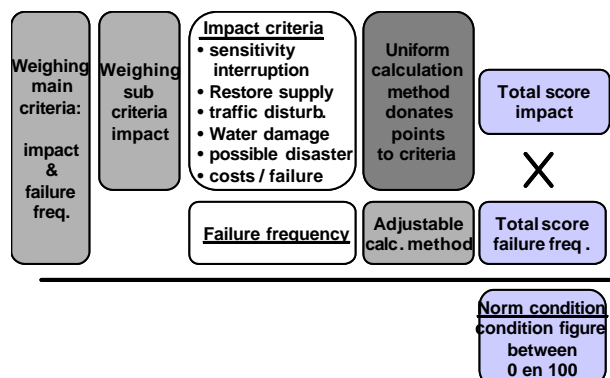
Fig. 17 - Customer perception calculation

The second category is the frequency of failure. The psychological impact of the first failure is different (less) than that of the second, third and more failures within a period of time. The failure frequency has a multiplying effect on the impact criteria. This is visualised in figure 17

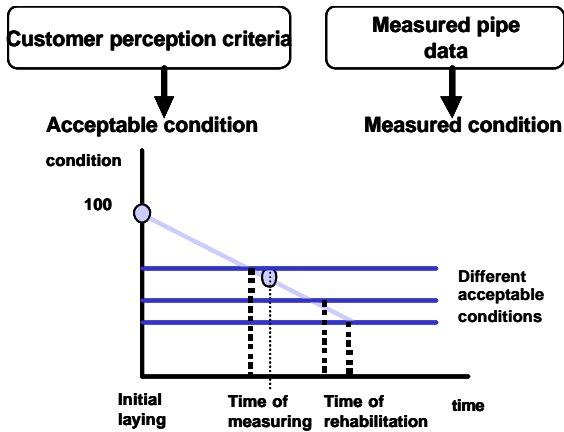
Fig. 18 - Dynamic customer perception

Customer perception is a dynamic item. The customer perception can change over time and will change when multiple failures occur in a restricted area and limited time. Figure 18 summarises this.
