Investigation of ERCP-Scope X-32

following detected contamination after cleaning and disinfection

--- REPORT OF THE FORENSIC ENGINEERING INVESTIGATION ---

Final version – May 15, 2017

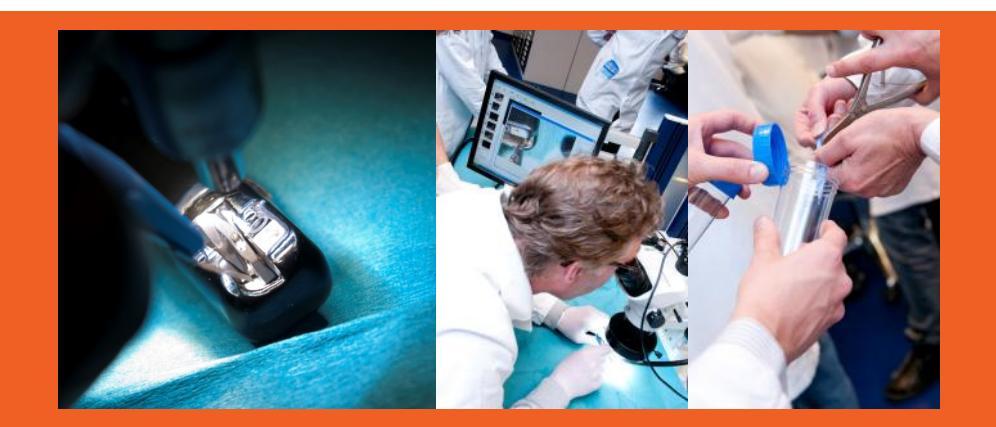
- scratches and grooves on the tip housing surfaces under the forceps elevator,
- whitish scale on the tip housing and brownish scale on the metal surrounding the forceps elevator. Scale is sampled by scraping with a scalpel {5412, 5423, 5434}.

Figure 6: From left to right: scraping a sample of the whitish and brownish scale using a scalpel; overview of the work setting; cutting off scalpel point for packaging.

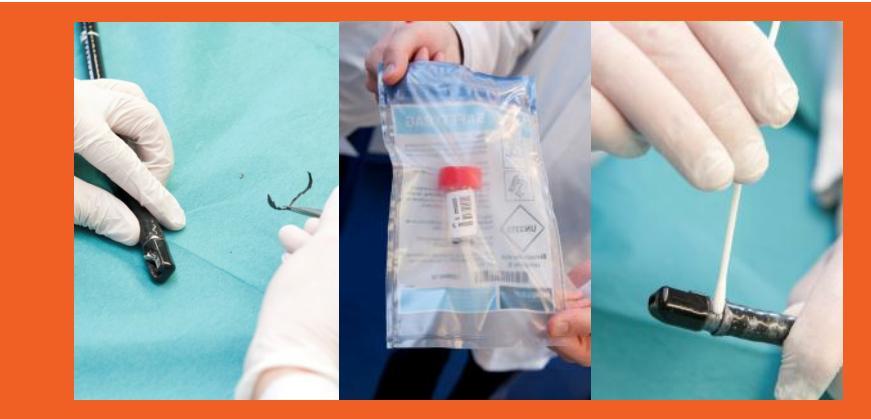
12:22h Lin removes the sealing that connects the hard plastic cap of the tip with the cardan rubber. This sealing is packaged for testing {5445}. Next, after removing the sealing and a part of the cardan rubber, the section of the steerable part of the tip that became exposed is sampled with a swab {5456, 5467} (Figure 7).

Figure 7: (Leftmost two) Removing and packaging of the sealing between the hard plastic cap of the tip and the cardan rubber that covers the cardan section (steerable section of the scope). (Far right) Sampling under the cardan rubber.

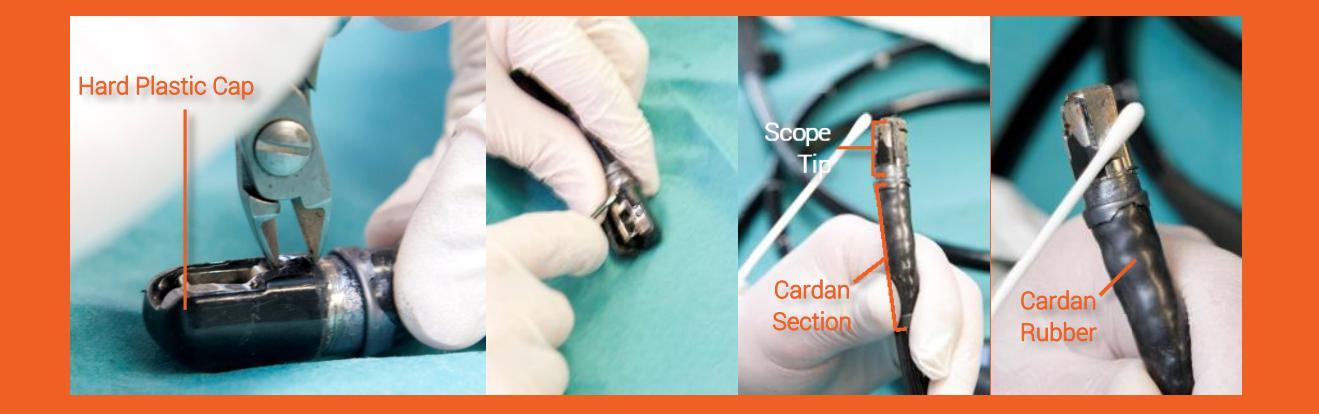
Lin removes the hard plastic cap from the tip by cutting it open, which is then packaged {5478} (Figure 8). Next, the area exposed under the cap is sampled {5489, 5490} (Figure 8).

Figure 8: (Leftmost two) Cutting open and prying loose the hard plastic cap off the tip. (Rightmost two) Sampling the exposed parts under the removed hard plastic cap.

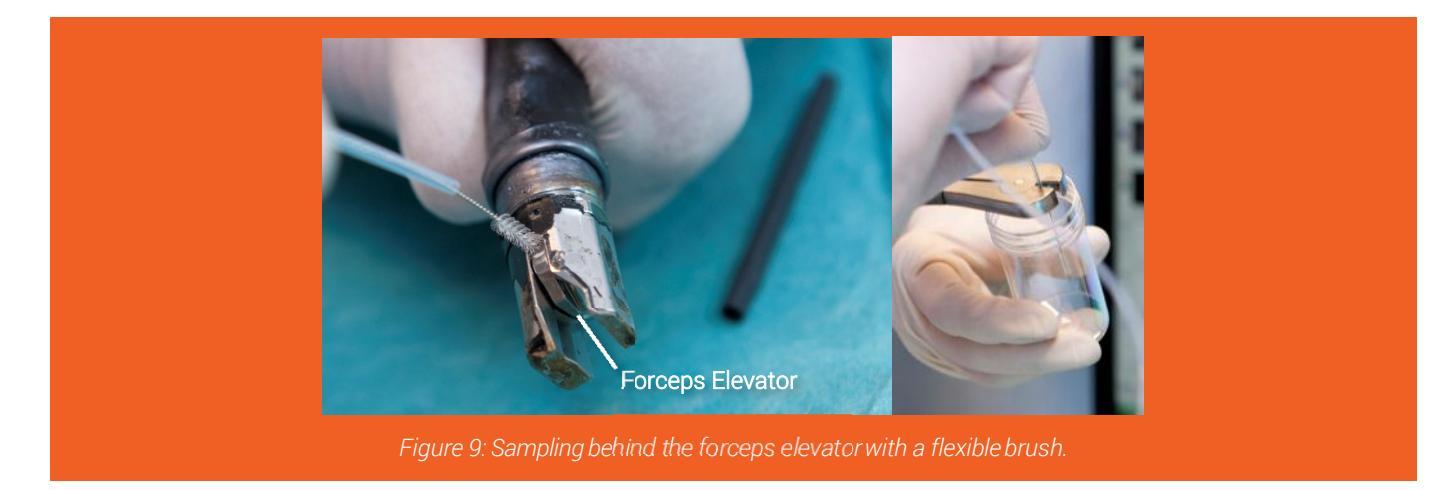
An attempt was made to sample behind the forceps elevator using a flexible brush because swabs were too thick. This worked partially, but the space was too limited for the brush to sample the entire area behind the forceps elevator {5521} (Figure 9).

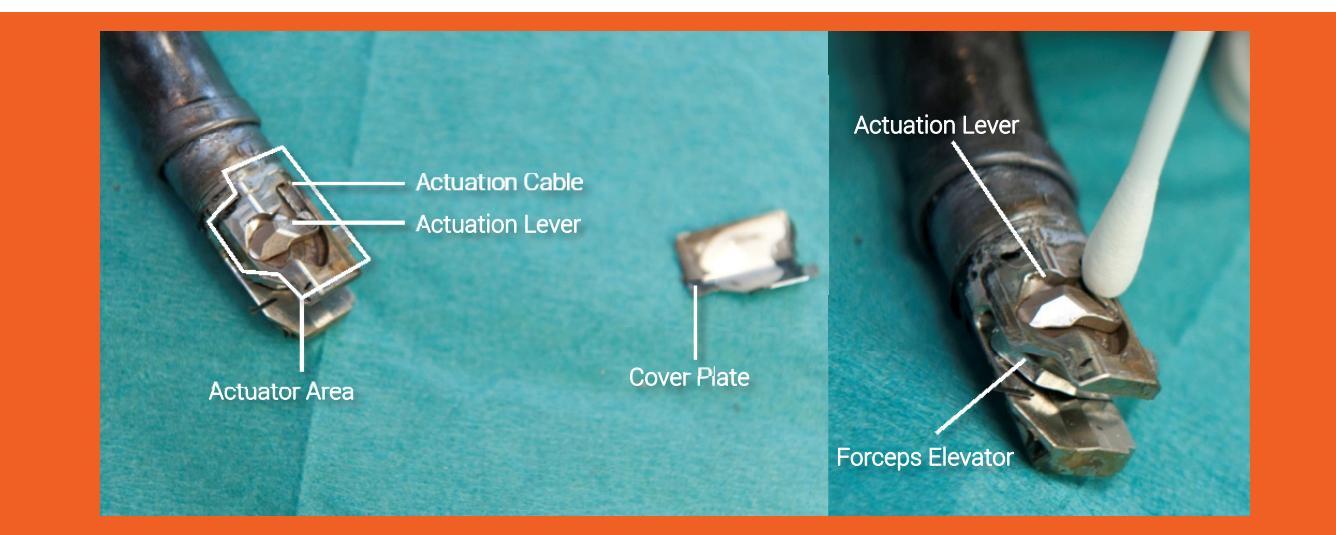
13:27h CONTINUATION. *The investigation team* is present again in the manufacturing hall. Lin removes the cover plate that covers de actuator area of the forceps elevator (Figure 11). The cover plate is packaged for further testing {5609}. The actuation cable is sampled twice with swabs {5542, 5558} (Figure 12).

The investigation team clearly notices that all metal surfaces inside the opened actuator area are covered in brown scale. Bacterial testing of the samples will have to show whether this is oxidation, blood or something else.

Figure 12: (Left) Removal of the cover plate from the actuator area (arrow) of the forceps elevator. (Right) Sampling the actuation cable of the forceps elevator.

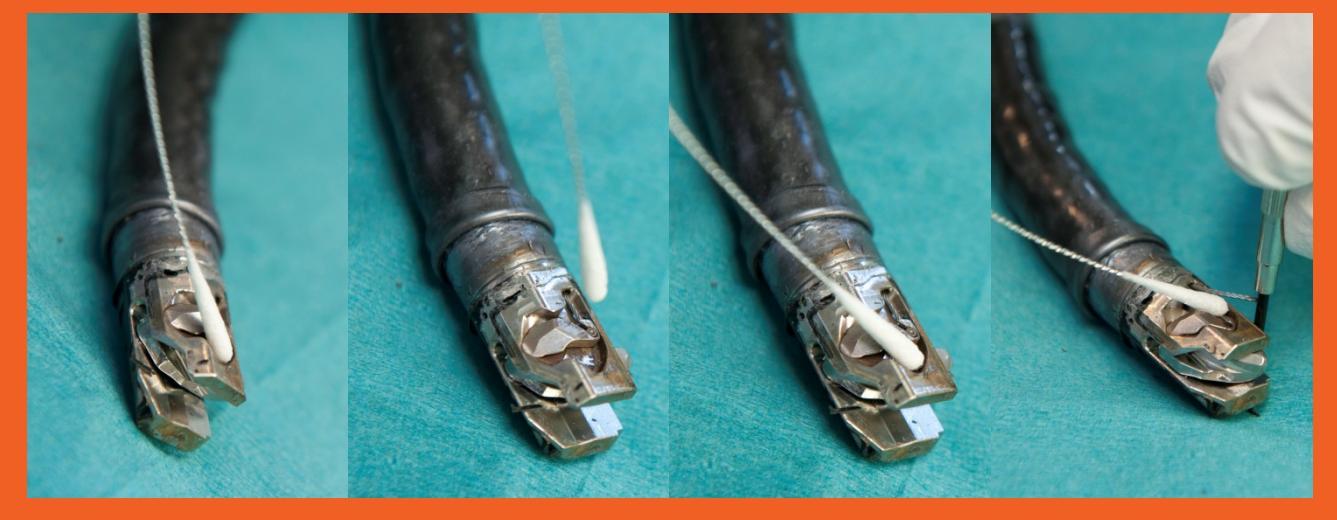
Four swab samples were taken from the actuator area, the area containing the actuation lever with which the forceps elevator is rotated {5560, 5573, 5584, 5599} (Figure 13).

Figure 13: Sampling of the actuator area in which the actuation lever of the forceps elevator is housed

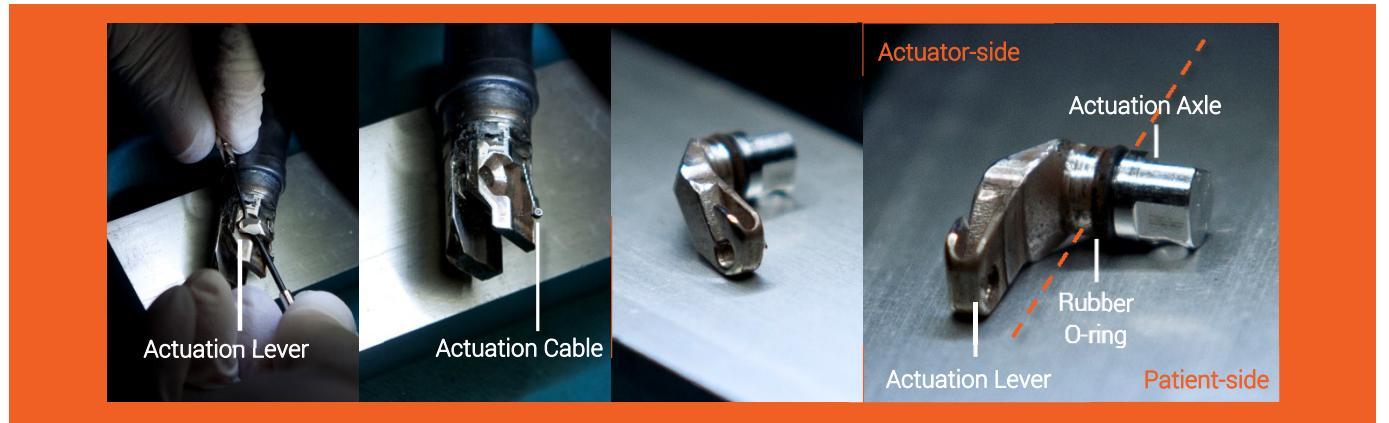
13:54h The actuation lever and actuation axle form a single part. It is taken from the actuator area and put under the microscope (Figure 14). There is a rubber O-ring around the actuation axle that should create a water and bacteria tight seal between the actuator area and the patient.

Figure 14: From left to right: removing the actuation lever with actuation axle; actuator area from where the lever was removed; actuation lever with actuation axle and O-ring photographed from the side that was in the actuator area; actuation lever with actuation axle and O-ring photographed from the patient-side.
