# Pumping stations and water transport

Operation and maintenance of  
networks

ct5550

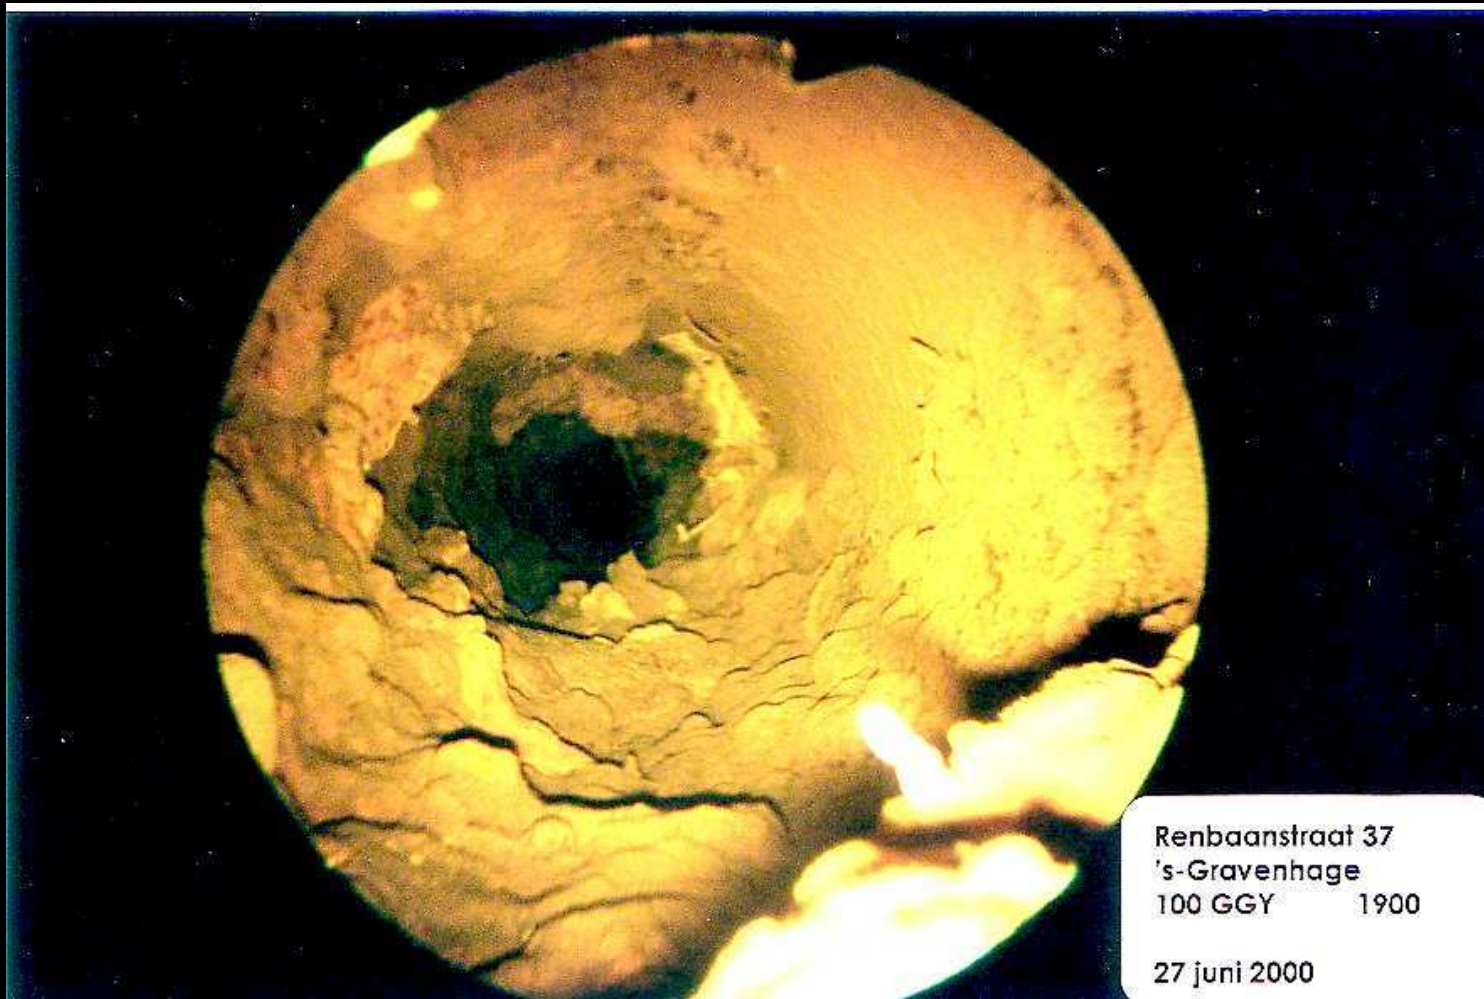
# Ø100 Cast Iron (1900)

Renbaanstraat 37  
's-Gravenhage  
100 GGY 1900

27 juni 2000

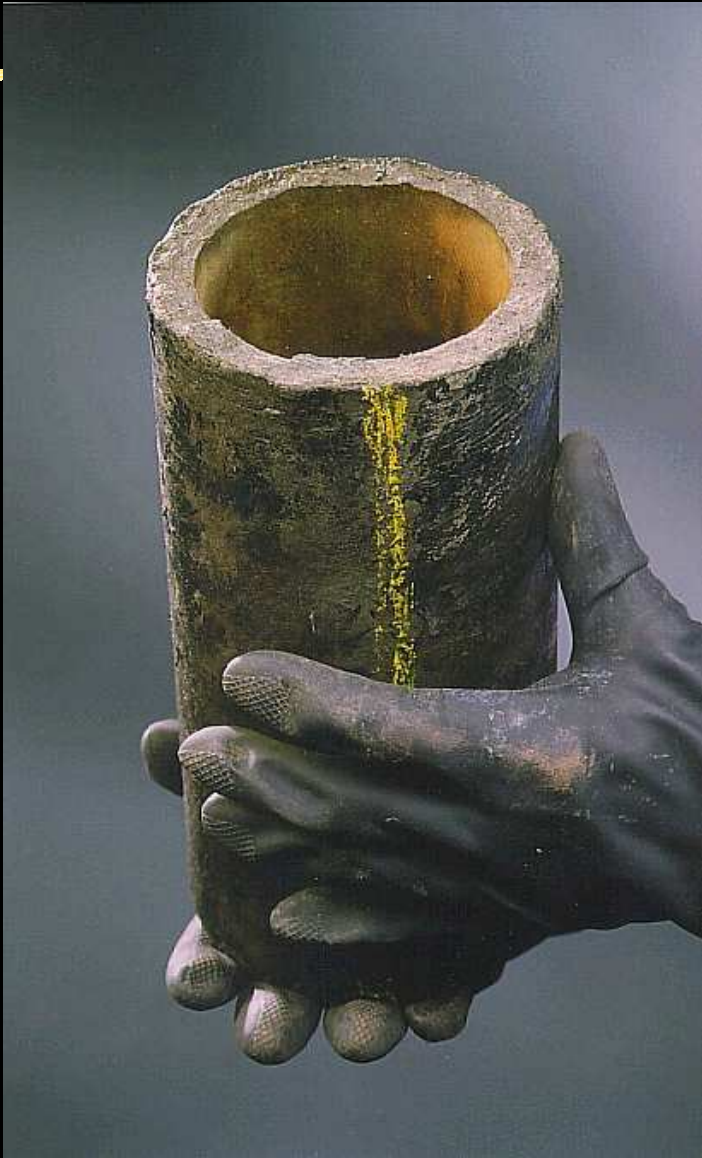
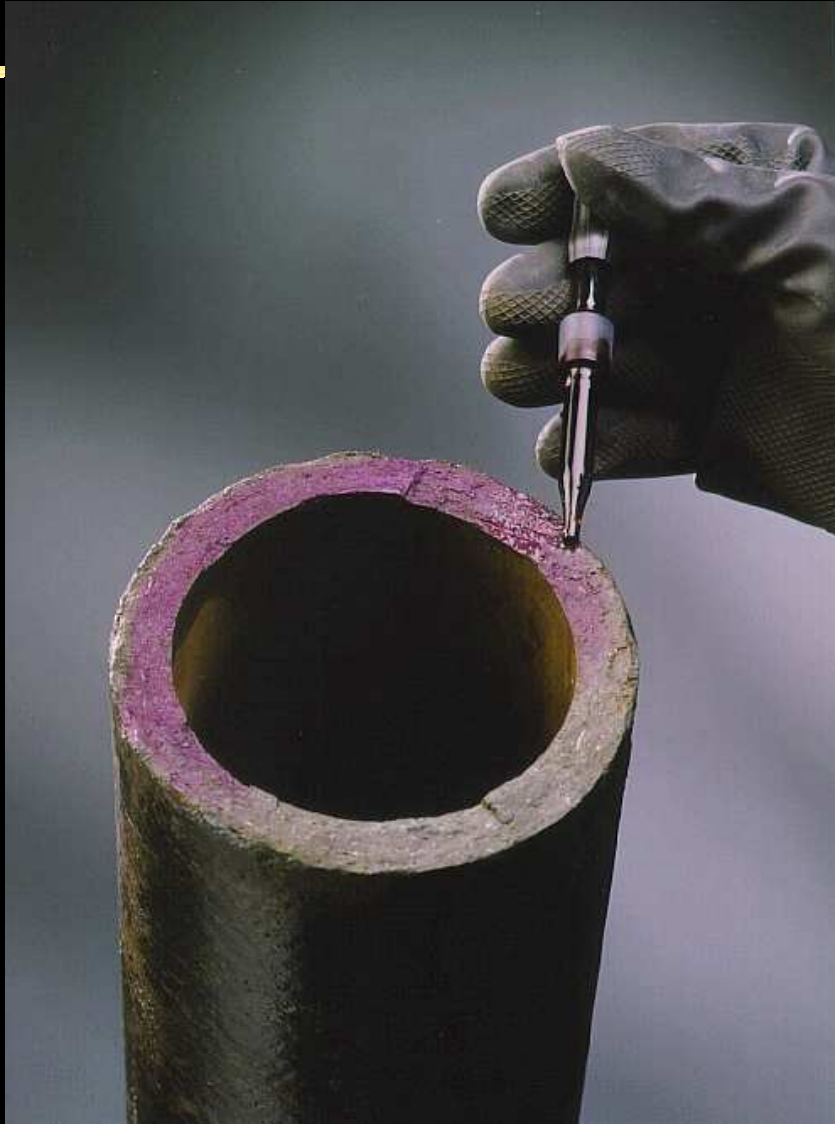
# Measuring AC-corrosion: Phenolphthalein field test

- Dripping phenolphthalein on the full sectional surface of the pipe
- the none-corroded surface colours purple, the corroded surface stays colourless

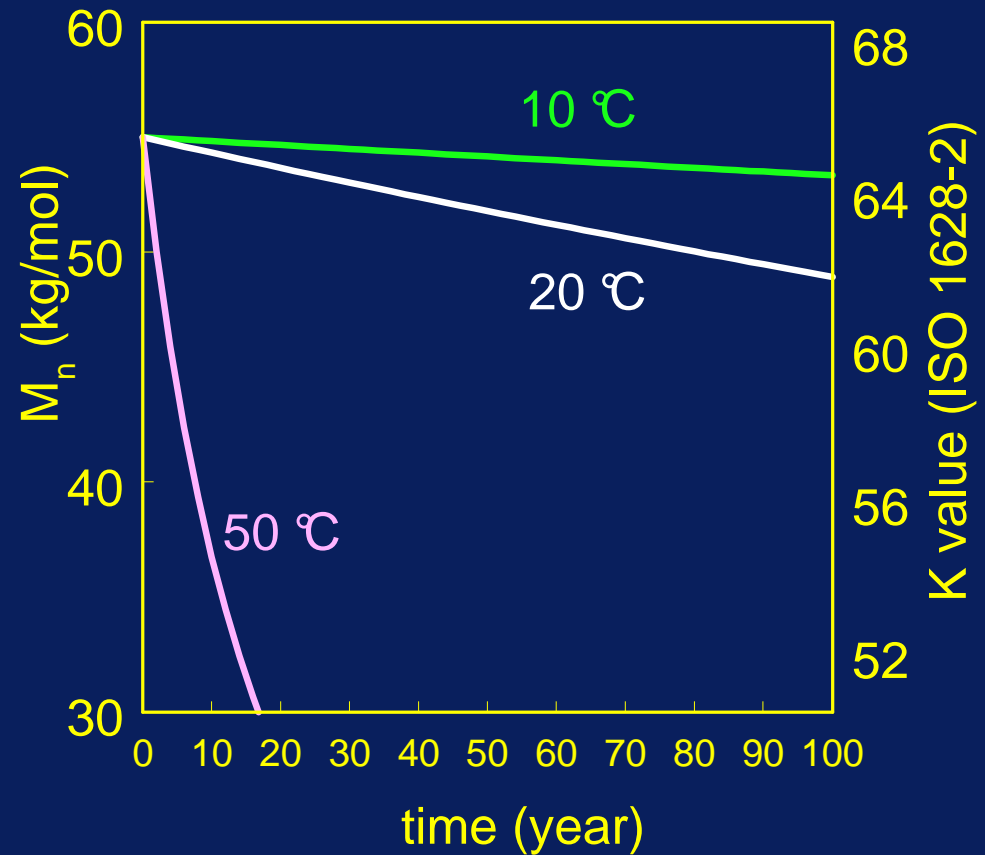
# Chemical ageing

- Degradation kinetics from DHC experiments at elevated temperatures
- Most negative scenario indicates that at 10 °C the K-value decreases from 66 to 65
- Higher temperatures causes an accelerated degradation rate

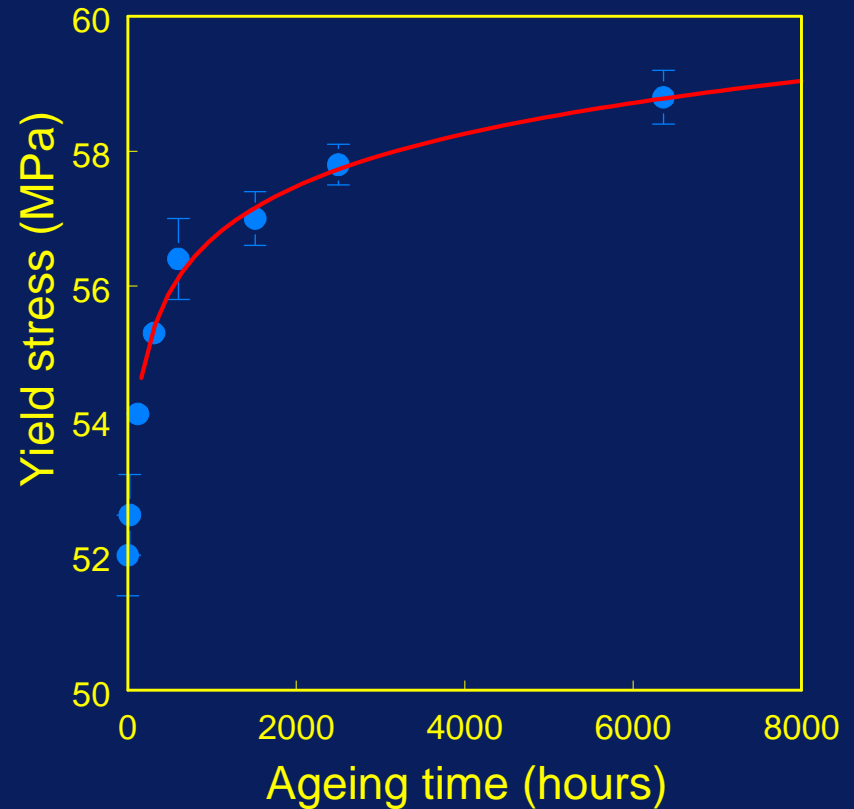
# Physical ageing

- Accelerated ageing of new PVC pipe at 60 °C leads to an increase in yield stress
- Expectation:  
The yield stress is an indication for the age of the excavated pipe

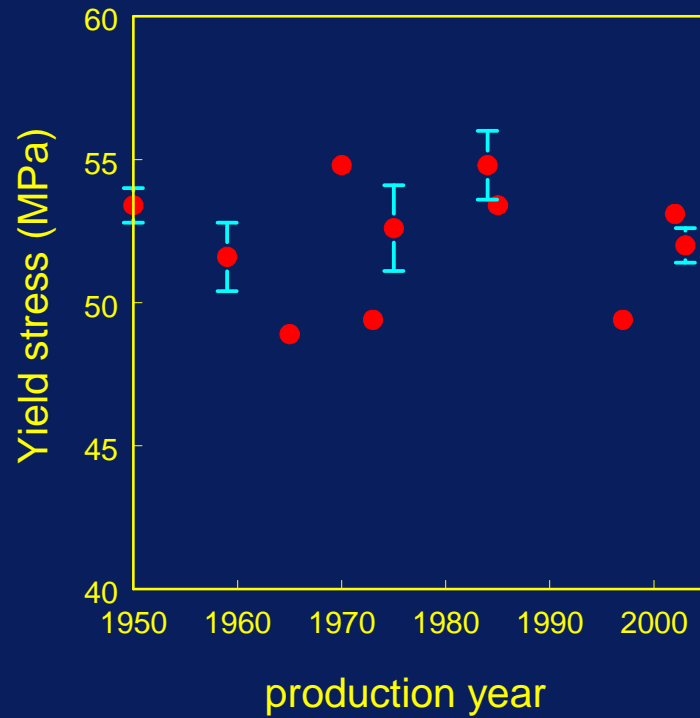
# Physical ageing

- Yield stress depends on wall thickness and not on age
- Thicker wall cools more slowly and generates more physical ageing
- The state of physical ageing is determined immediately after production and hardly changes in service

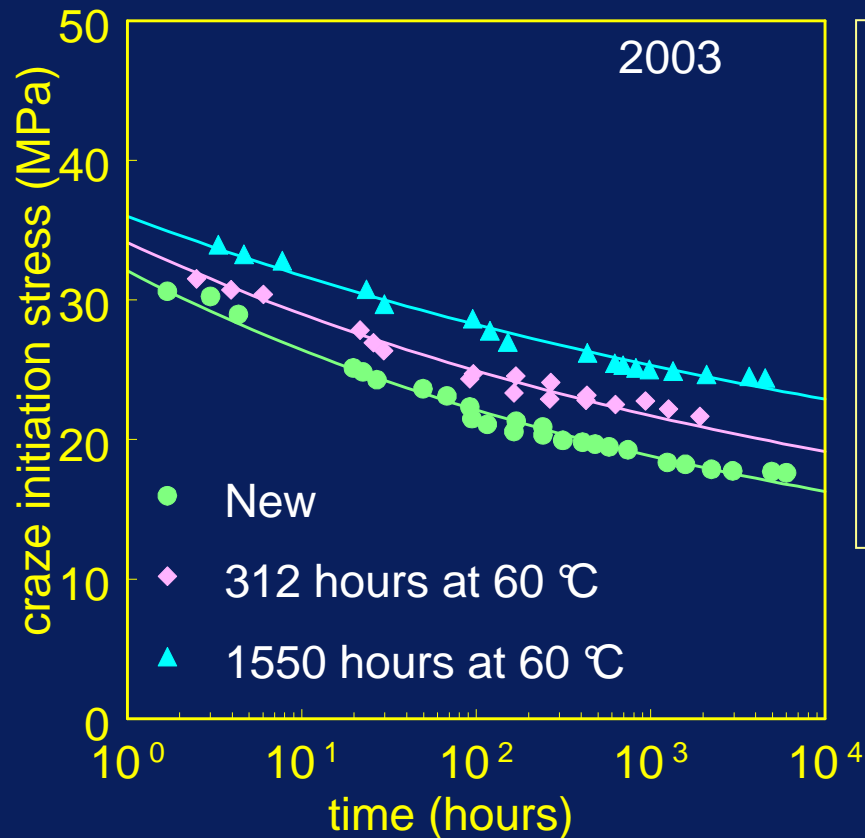
# Craze initiation

Annealing of pipes at 60 °C increases physical ageing

Physically aged pipes have a higher resistance against the formation of crazes

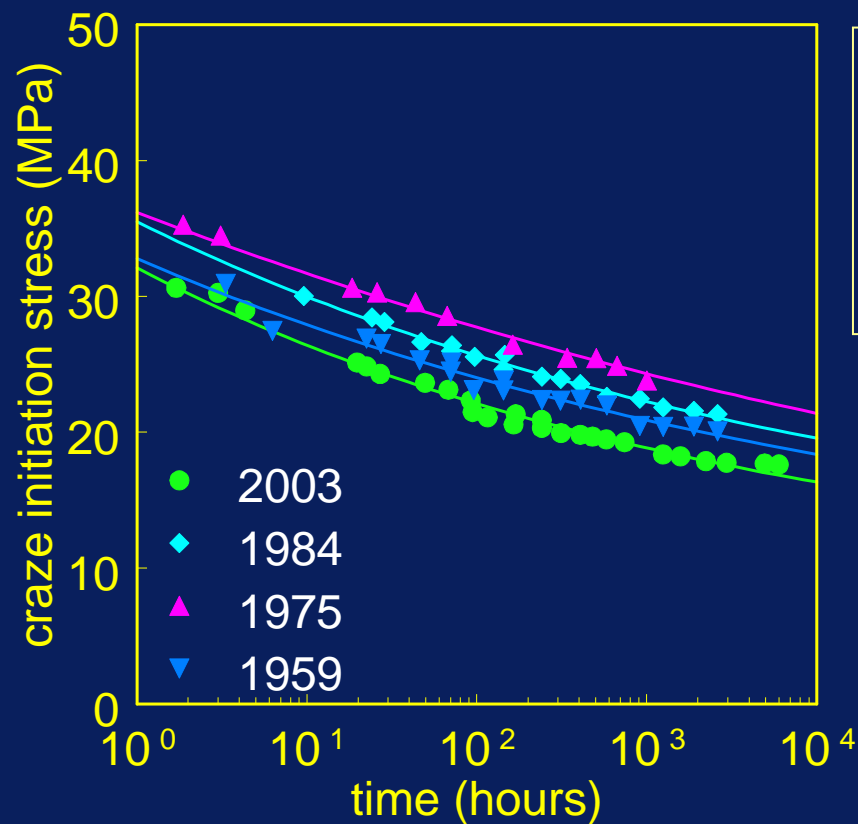
# Craze initiation

Craze initiation stress does not depend on the age of the pipe

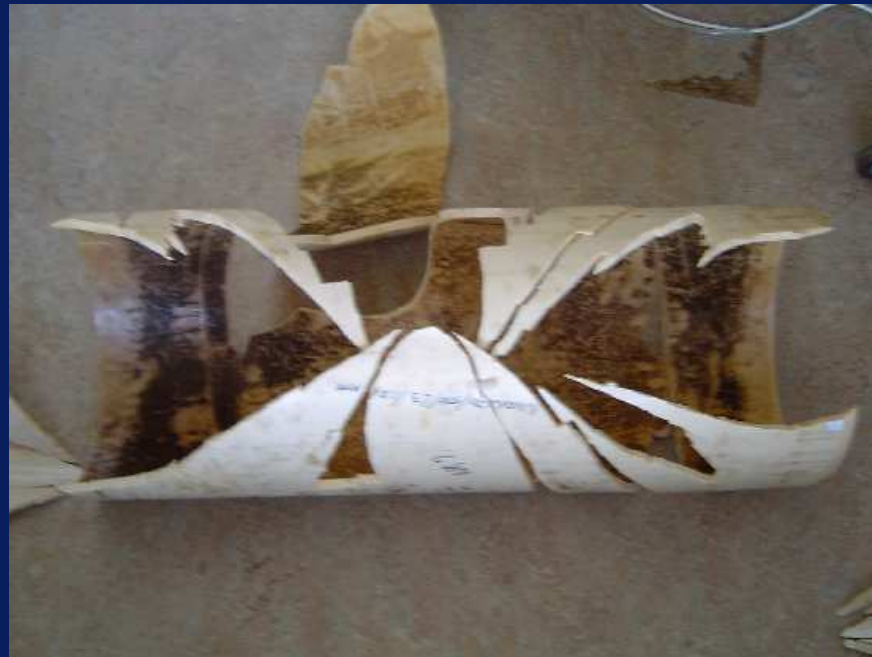
# Burst pressure

- Pipes are hydrostatically pressurised and the time until failure is monitored

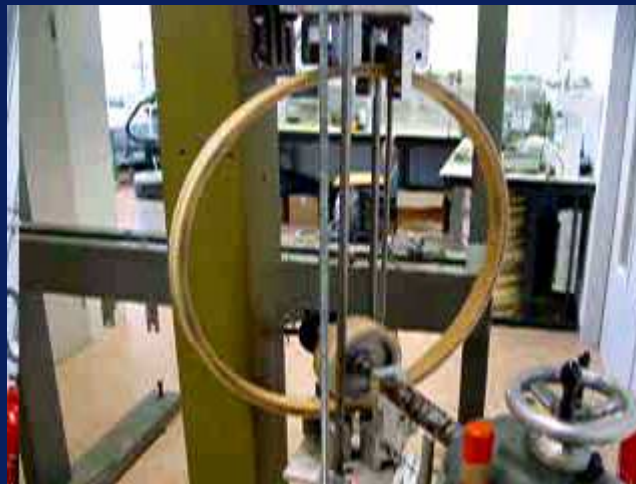
# Fatigue

- Loaded ring is rotated
- Number of cycles until failure is monitored versus stress level applied

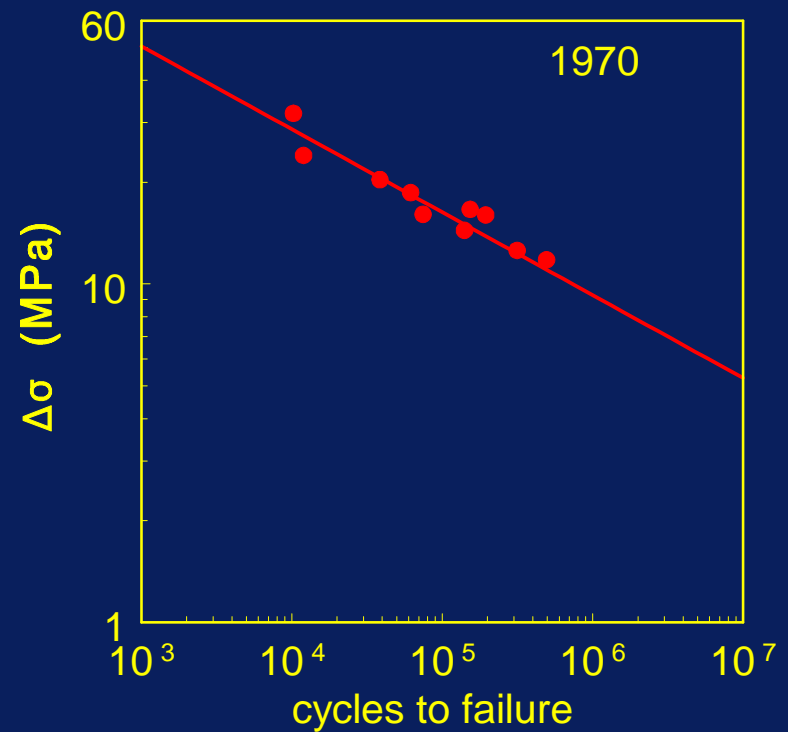
# Fatigue

- Fatigue stress level that can be withstand for  $10^7$  cycles in 100 years at 20 °C (=10/hour)
